Full Wall Slide Won't Move Troubleshooting and Repair 2014 Discovery 40F

INTRODUCTION/SUMMARY

This file documents troubleshooting an inoperative full wall slide on a 2014 40F Discovery. The malfunction occurred during the January 2019 SE DOAI Rally at Lazy Days RV Resort. Several people (Mike Weiher, Kerry Pinkerton, Jim Pinkerton, Rick Blaher, Harry Terrill, Marshall Godwin (remotely)) participated in the process over a period of 4 days during the rally. Mike owns the coach and Rick acted as the scribe. The others combined their knowledge and troubleshooting skills to identify and correct the malfunction's cause. We also had consultation with REV Technical Support during the process. All the full wall system major components were checked and eliminated to arrive at the root cause. A relay was found on the floor under the center dash that had gotten wet and was damaged. The relay was replaced and the problem resolved. The following slides and narrative document the troubleshooting and repair process.

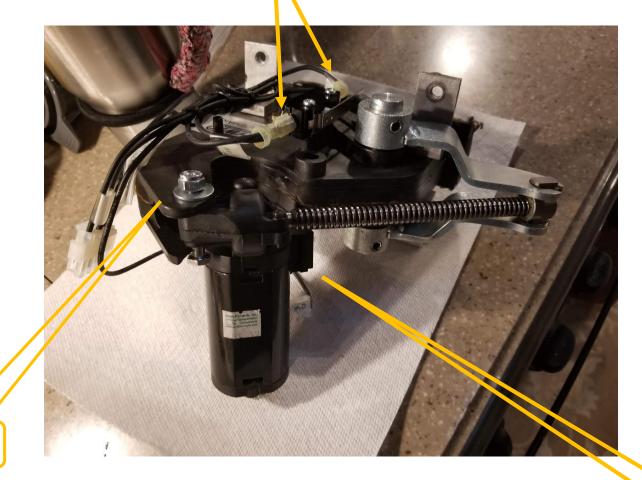
We first inspected the full-wall lock assemblies. Neither motor mount was broken. Each motor had 2 connecting wires and there were two connecting wires on a limit switch on top of the motor assemblies and a 6-pin (white) plug. All were secure. We did not immediately unplug and re-plug them to remove potential corrosion, but did so later in the process with no change in symptoms.

> Verify Motor Mount Secure

Verify 2 Motor drive connections secure+-9

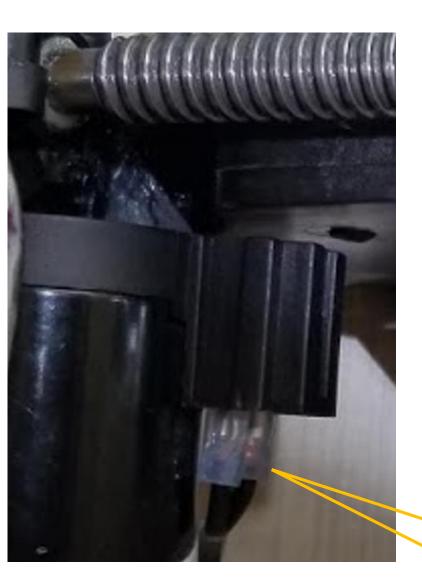
Manual Retraction (Electrical Jumper) of Slide Locks

- ✓ We used a 12V motorcycle battery to jump between the two pins on the lock motors and move the clamps.
- ✓ Reversing the jumper polarity will make the clamp move in the opposite direction.
- ✓ The jumper was used to manually move the clamps to the <u>stowed position</u> the clamp position necessary for the slide to begin to extend.
- \checkmark This step did two things
 - 1. Allowed us to see if the slide would extend once the clamps were stowed
 - 2. Verified <u>only</u> that the motors were both operational did <u>not</u> verify controller or limit switch operation.
 - 3. Properly stowed clamps (visually verified) for slide extension

Slide was tested after locks stowed and did not move. Had the slide moved, the problem would likely have been associated with the slide locks.

12V from motorcycle battery to 1 terminal, ground to other. Reverse polarity to reverse lock travel direction

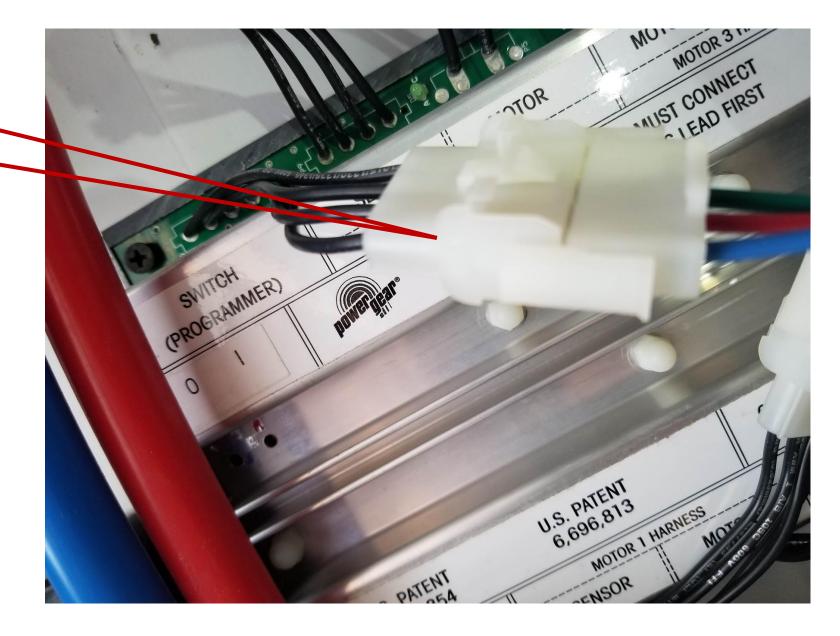
Full Wall Slide Controller

- 12. After reviewing wiring diagrams, pins 2 and 3, and then 1 and 2, on the slide controller "Switch" plug (Reference Diagram 1) were jumpered by Kerry. The slide moved both in and out. We retested with the lock motors connected and the locks extended/retracted properly. This step eliminated the locks, slide controller and lock controller as possible sources of the malfunction. The slide was checked again using the control panel switch, and it moved out and back in again. Upon extending the slide a 2nd time, it stopped moving about ½ way out and then wouldn't move in either direction after that. At this point we knew we could manually operate the slide by jumping the correct pins. We extended the slide for livability while we researched the schematics. The pins being jumped are inputs to the PowerGear controller from the HWH lock controller.

This plug was disconnected and jumpered to cause the slide to move in and out. See Reference Diagrams 2 & 3

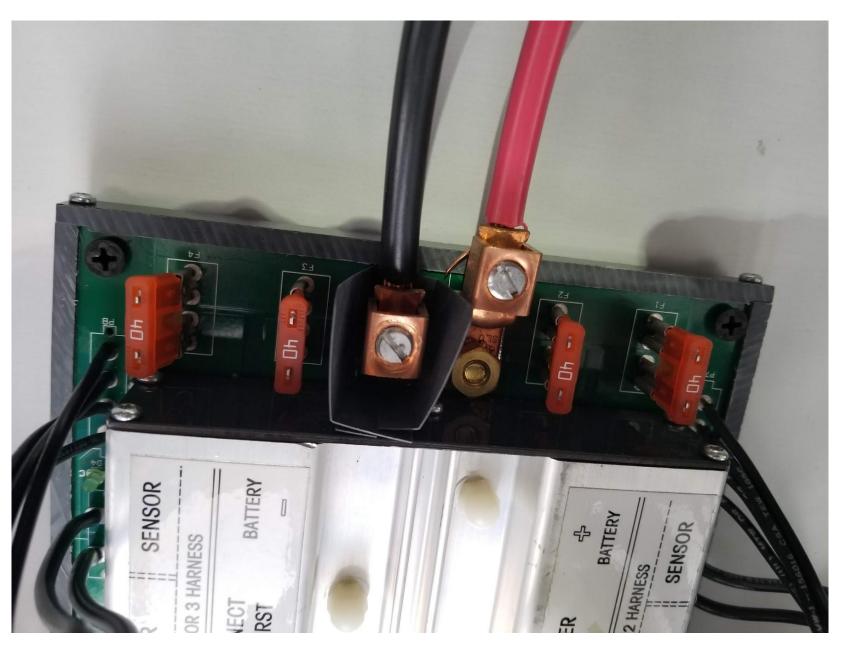
Full Wall Slide Controller Power Input

- 9. The slide controller has four 40-amp fuses (Slide 9), one for each of 4 motors. Only 3 of those are used, one for each of the 3 full wall slide motors. All the fuses were checked for continuity and were good. We did not check for voltage on each side of each fuse. Performing this latter task is useful to check the integrity of the fuse connections.

The voltage between the black and red wires should be 13.5 volts. Also, this is a place where you can get power to jumper the slide if needed to manually move it in or out.

The 40A fuses are for the motors. Since there are only 3 motors on the full wall slide, the 4th fuse is a spare.

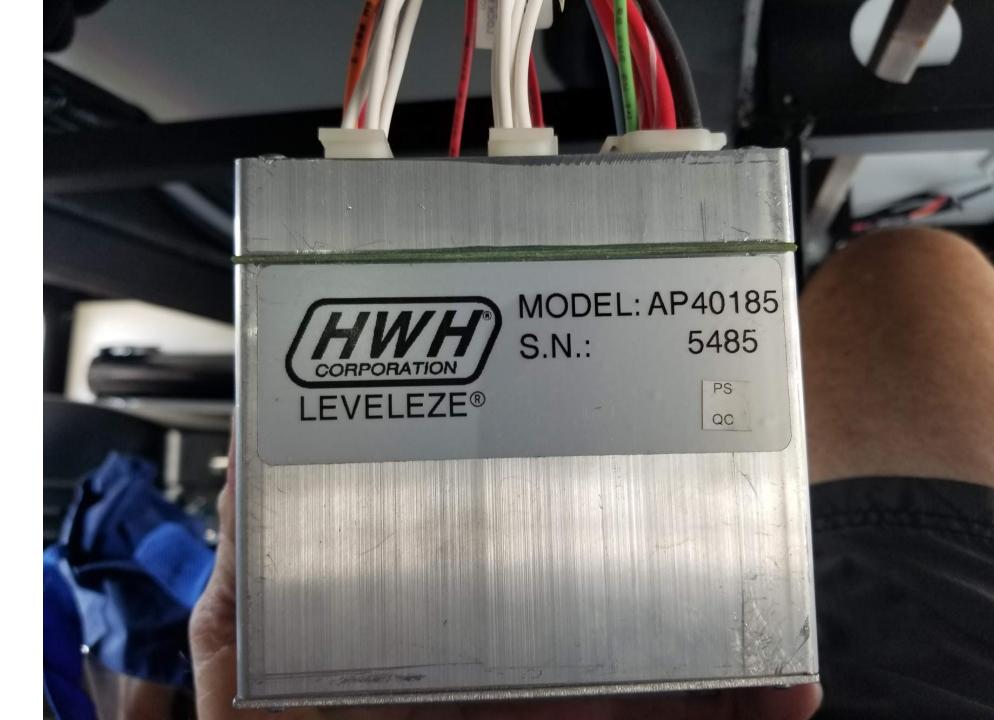
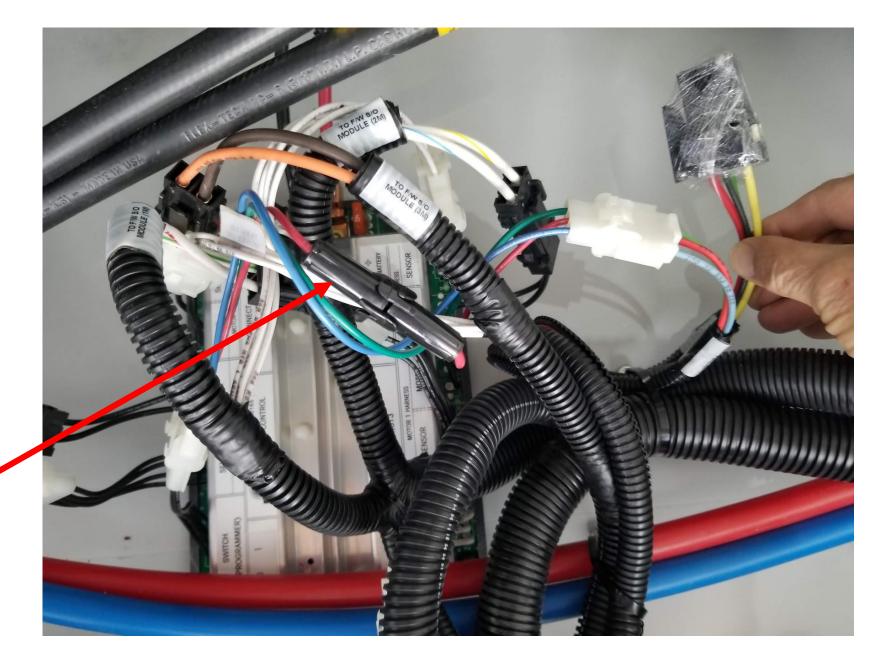
Full Wall lock controller

Don't be fooled by the title on the box. This is the slide <u>LOCK</u> controller and has nothing to do with leveling.

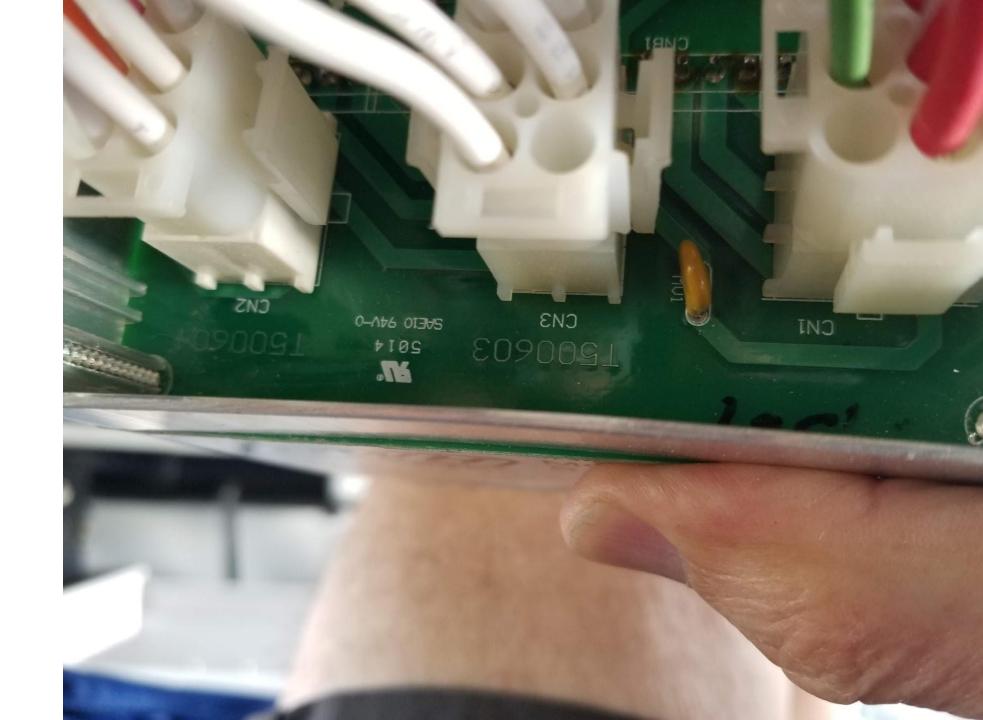
Quarter Amp Slide lock fuse 🗲

- 10. There is a ¼-amp in-line fuse (slide 11) between the slide controller and the lock controller. That fuse was good.
- 11. There is a 40-amp fuse that comes off the BCC (Reference Diagrams 3 & 4) and supplies power to a lock relay (Reference Diagrams 2 & 3) located on the basement ceiling near the slide and lock controllers. The 40-amp fuse tested good. The relay plug was cycled on and off a time or two at this point and appeared to be functional.

This fuse is in-line between the slide lock controller and the slide controller. Full Wall Lock Controller Close up connectors CN1, CN2, CN3 for Reference

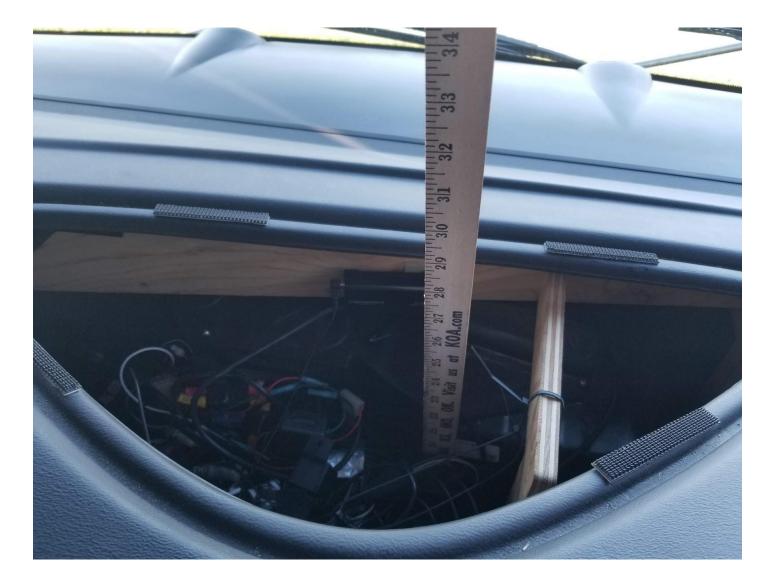
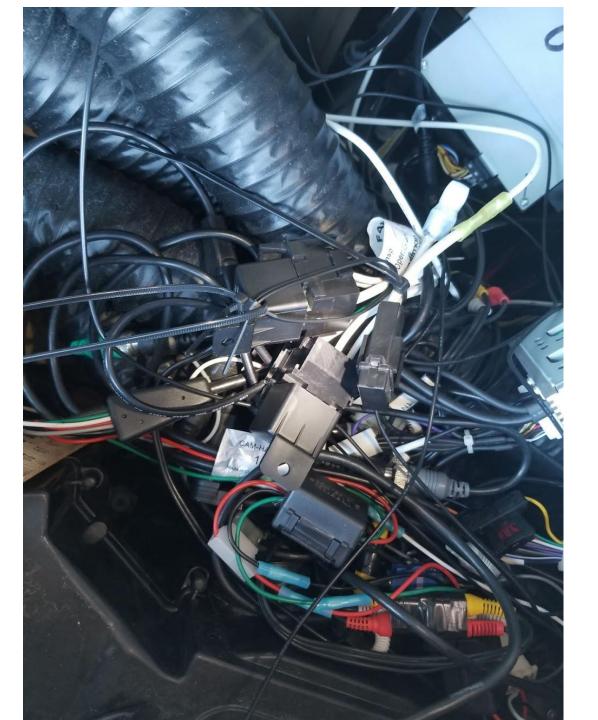
Yardstick distance to floor under dash.

- 17. Harry Terrill contacted REV technical support to try to find out where an interlock might be. He learned that there was an Ignition Interlock Relay in the central dash (Slides 15-16). We searched for and found the relay. Mike's coach had an unmitigated leak in that area. The area where they found the relay was wet. They found two relays one (Engine AC Clutch Relay) was burnt and the other (Travel Lock Relay) corroded (Slide 17). Both relays were replaced. This corrected the problem and the full wall slide now operated properly.

The floor at the dash is about 30 inches from the top. The two faulty relays were near the floor. The floor was wet due to a persistent leak.
