As originally diagnosed by Jim Godward, the Vehicle Data Unit (VDU) installed in the 1999-2001 Freightliner chassis has significant manufacturing quality control issues. The issues have lead to erratic performance and some frustrating instrument cluster problems, though non of the problems are known to have caused a shut-down or need for road service. This note addresses one of the instrument cluster issues, false low air pressure warnings on both the warning light and pressure gauge. (In fact, the Freightliner representative at the 2006 Quartzite Newmar Rally indicated that the vehicle would run and drive without an operating VDU, but with no instrument panel gauge operation. This is untested by the writer.)

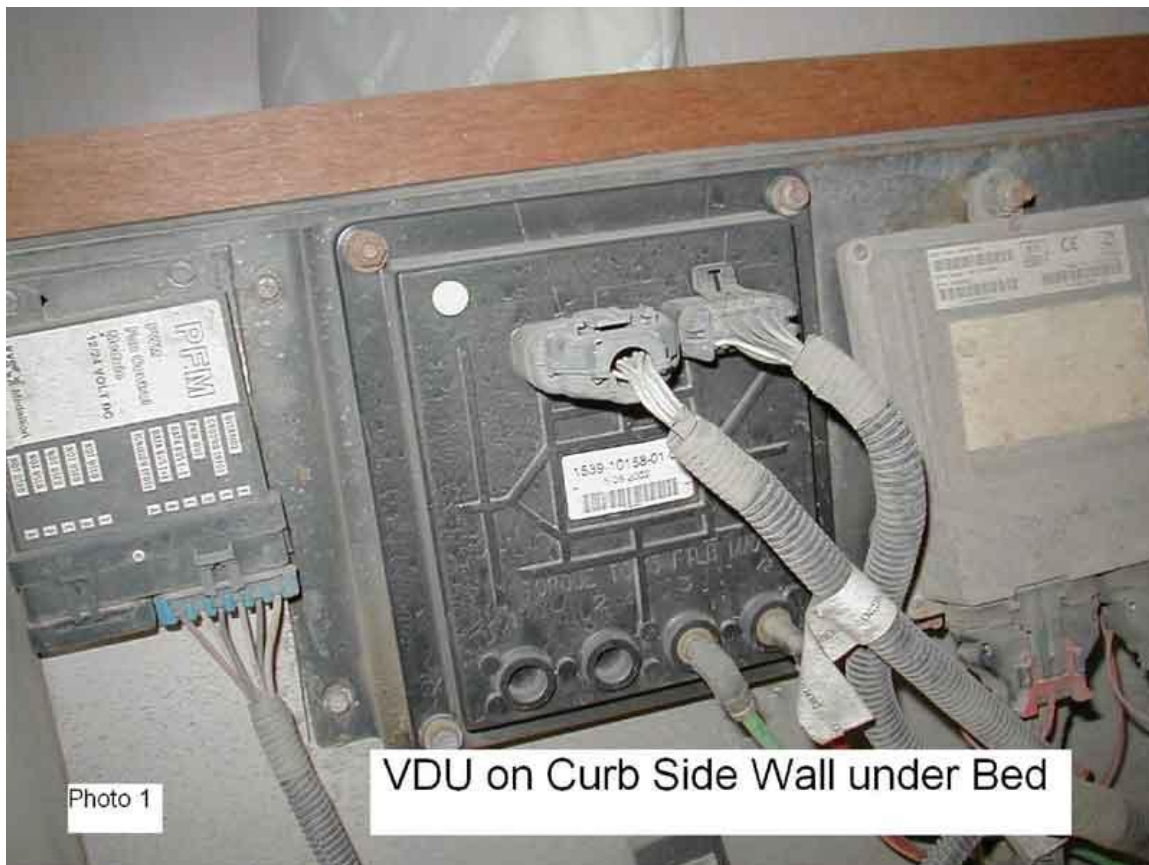
The VDU is a small black box which gathers and conditions various vehicle data destined to be displayed on the drivers instrument panel. This data is multiplexed onto a single digital bus, and passed to the instrument cluster, where it is de-multiplexed and displayed by the various individual instruments. In the 1999-2001 coaches, the box is attached to the curbside vertical engine bay wall, accessible by lifting the under-bed engine hatch. The box is approximately six by seven inches, less mounting flange, and one inch thick. It is attached by four small bolts in the corners, with rubber shock mounts surrounding each mounting bolt. The VDU has two multi-wire quick disconnect plugs and two small air lines of ¼ inch diameter attached. The airlines are color coded red and green and are apparently routed to the front and rear air brake reservoirs. The VDU is easily identified by looking for the color coded air hoses. Photo 1 below show the VDU mounted in under the bed in the engine compartment. The mounting bolts, quick release plugs, and the air lines are clearly visible.

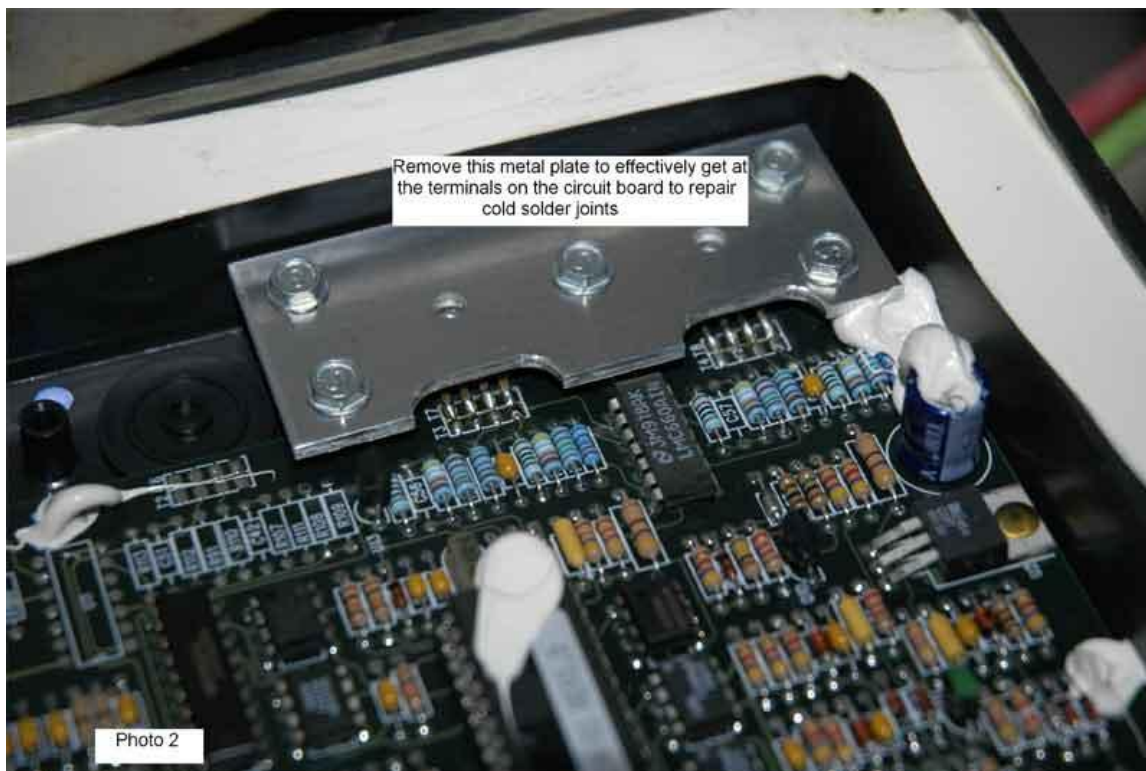
The primary quality control problems are with cold solder joints on the air pressure sensors, which become immediately clear when the unit is opened. Upon opening the VDU one will observe that the internals of the VDU consist primarily of a single printed circuit board and two attached brake pressure sensors. The air pressure sensors are covered by the small screw mounted aluminum plate which should be removed for repairs, shown in Photo 2.

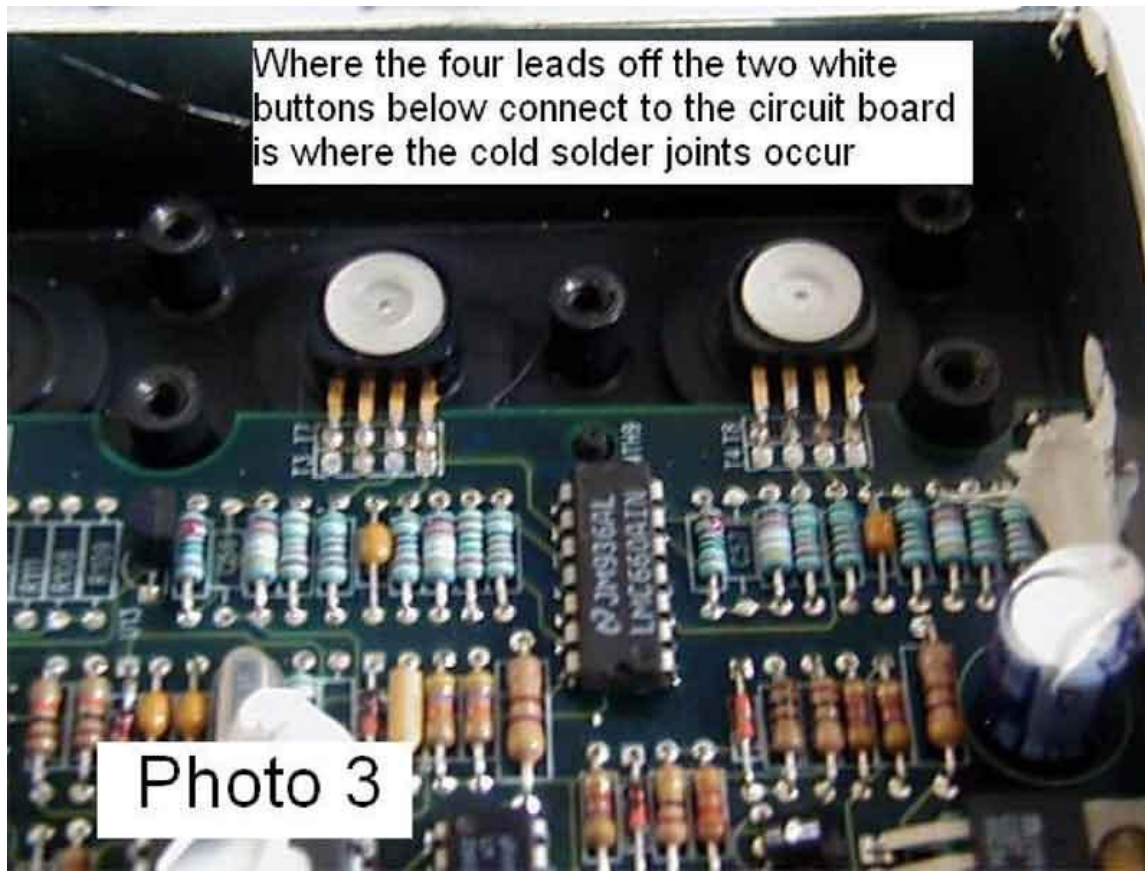
The primary soldering problem seems to be with the four attachment leads that each of the two brake sensors have on the printed circuit board. The connections to the air pressure sensors are just visible in the "notches" of the aluminum cover. (See picture below with cover removed) In both the Godward and the Epting cases, the solder joints were "cold." (Cold joints are characterized by a dull, grainy, rough appearance. Good joints are characterized by a bright, shiny, smooth appearance which "flows" onto the subject material.) All eight of the attachment leads (See Photo 3) had obvious cold joints, and there were visible cracks in some. This is an easy fix for someone with soldering experience, even without if careful.

The conductors and component leads on the VDU are quite small, though certainly larger than the current microcircuit level. These components cannot tolerate a lot of soldering heat, so a small iron is needed. Repairs are clearly within the realm of possibility, with a small pencil tip soldering iron and some care. I purchased a 40 watt pencil tip iron and a bit of fine resin core solder at Radio Shack. Just apply the tip of the soldering iron to each of the eight joints for a few seconds, and apply a very small drop of fine, resin core solder. After using the soldering iron, I now think that a 30 watt iron would have been even better, but one wants to get a good joint and not produce another cold joint. The entire operation took no more than an hour, once all the planning and preparations were made. If one has no soldering skills, or experience, then it would perhaps be better to find a friend who does.

When finished, the VDU must be resealed to avoid moisture and road spray. The original sealant is a tough, somewhat pliable material of undetermined origin. Mr. Godward, and aerospace electronics expert, advises the use of a small amount of butyl rubber sealant to reseal the unit. If this is unavailable, an epoxy would seem to work well. Mr. Godward advises against silicon since it releases a potentially destructive acid as it cures. Reinstallation is straight forward, but care must be exercised to avoid over tightening the four shock mount bolts. The shock mounts should not be compressed since this might distort the case, or cause excess vibration. The elastic locking nuts will prevent the nuts from backing off. The air hoses will lock in place when pressed back into the pressure fittings. Reconnect the chassis battery and test the repair.
