Discovery 2011 40X Flooring Replacement

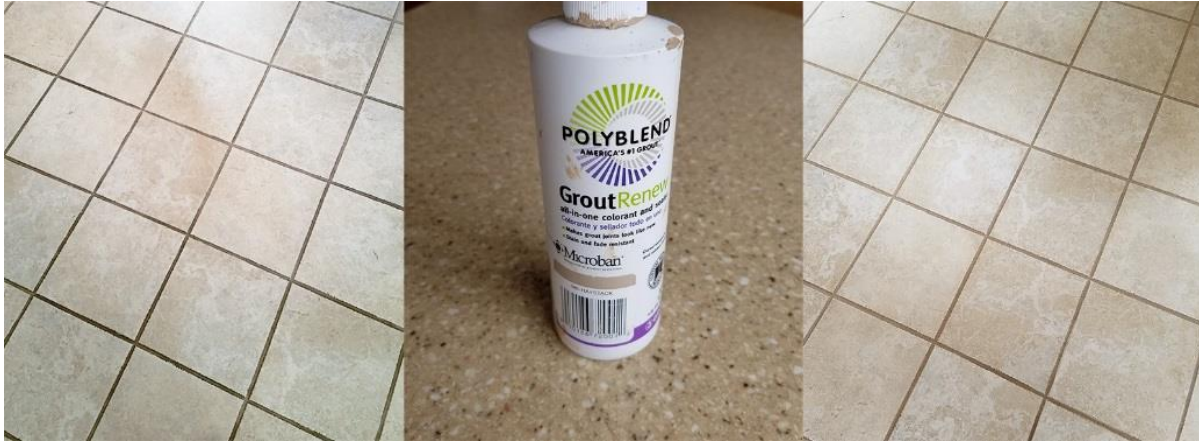
As we examined the tile flooring in our coach we realized that the ceramic tile was in excellent condition but the grout was not. No matter what we used to try to clean it, it remained inconsistently stained. In some places the grout was almost black.

The easy solution was to get a bottle of grout colorant and within an hour, the grout was consistently the same color throughout the coach. Before and after images:

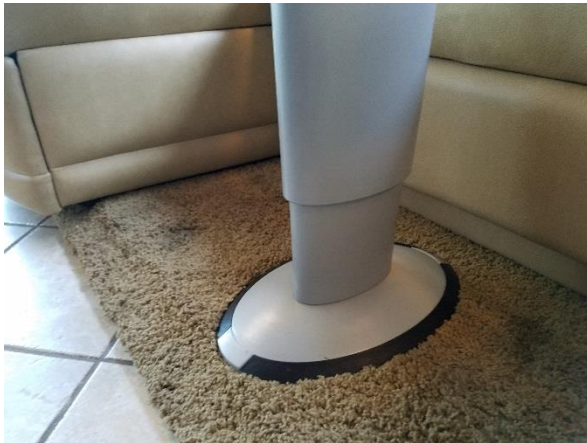
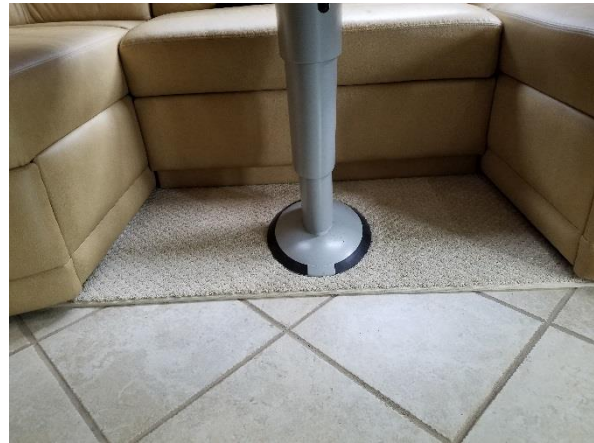
For us, the most logical solution was to replace upgrade all of the carpeting. The existing carpet was a dirty and stained kind of 70's-ish gold shag. We had some carpeting left over from our previous coach and as it was still available so we purchased enough to complete the task for about \$260. This carpet wouldn't have been chosen if we often had kids or pets with us, but we wanted to offset the darker woodwork with something a bit lighter. Here is a before and after of the dinette area.

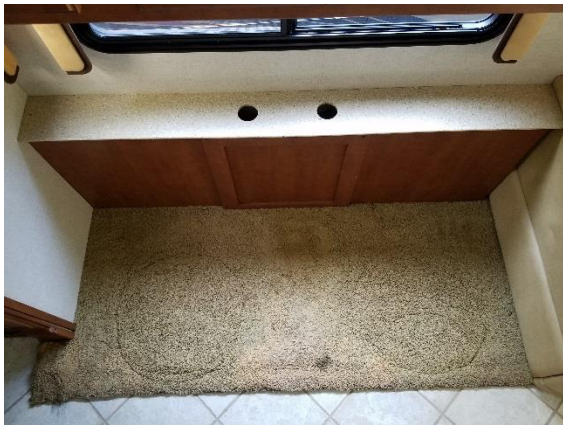
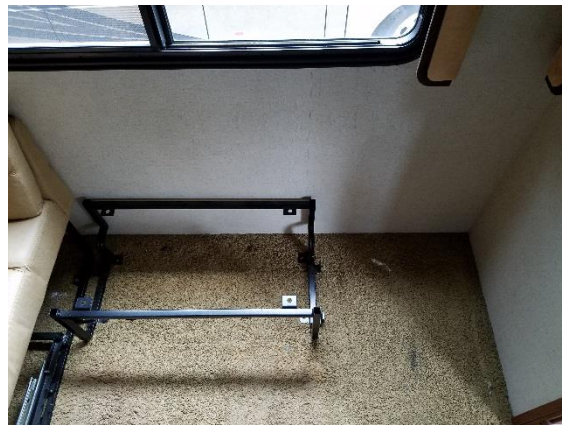
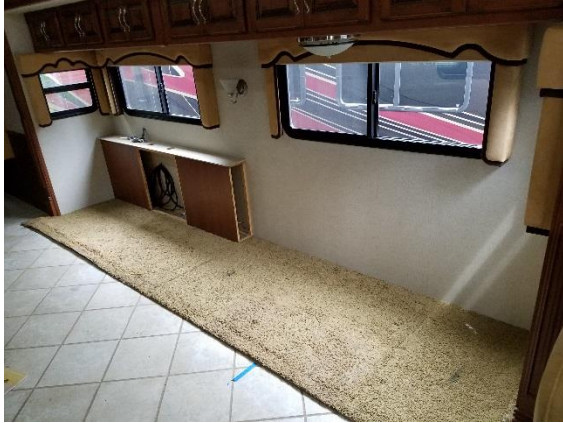
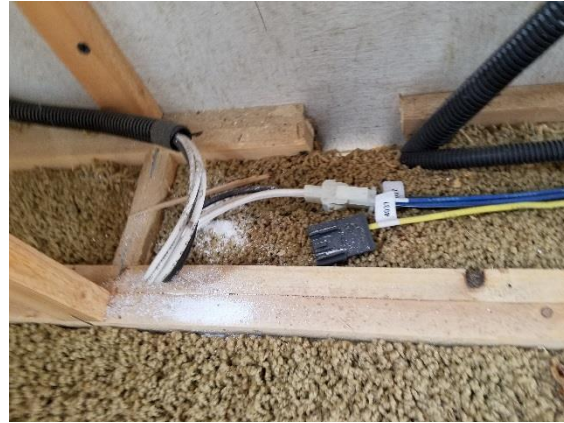
We started by removing the two Euro Chairs and Wraparound Dinette and Table, carefully measuring the locations of the bolts for the seat belts and dinette frame. We could then unscrew the cabinet from the wall behind the Euro Chairs and pull the old carpet up. I often used blue painter's tape for temporarily markers.

The original carpet was mostly held in place by 3/16" narrow crown x 3/8" leg 22 gauge fine wire upholstery staples. The stapler for this size staples is about \$150. I decided to use 1/4" crown x 1/2" 18 gauge staples as I already had the stapler for that size.

I wondered why the original staples were so short so I used a stud finder on the slide out floor and found that although most of the floor was a double layer of plywood, there were four bands of metal ribs running the depth of the slide floor at 3/8" below the top layer of plywood. I marked their locations so that I wouldn't attempt to drive 1/2" staples into the metal bands.

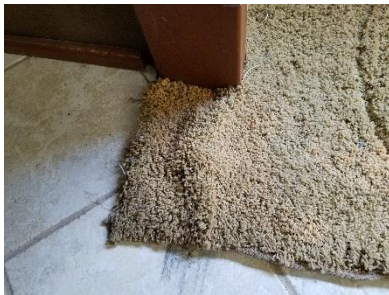
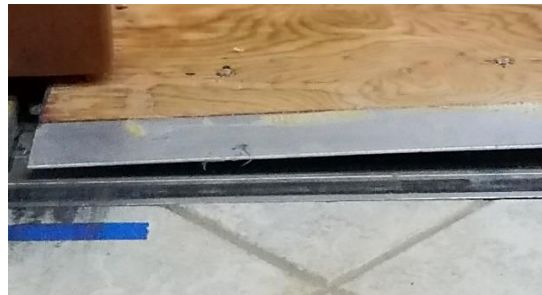
The ceramic tile was marked at the left end of the slide floor and when the carpet was removed, I found that this was the result of the slide floor being warped.

This likely occurred with the slide retracted as this corner would easily be stepped on while walking around the end of the slide to reach the rear hallway. I'll need to address the warped slide floor later.

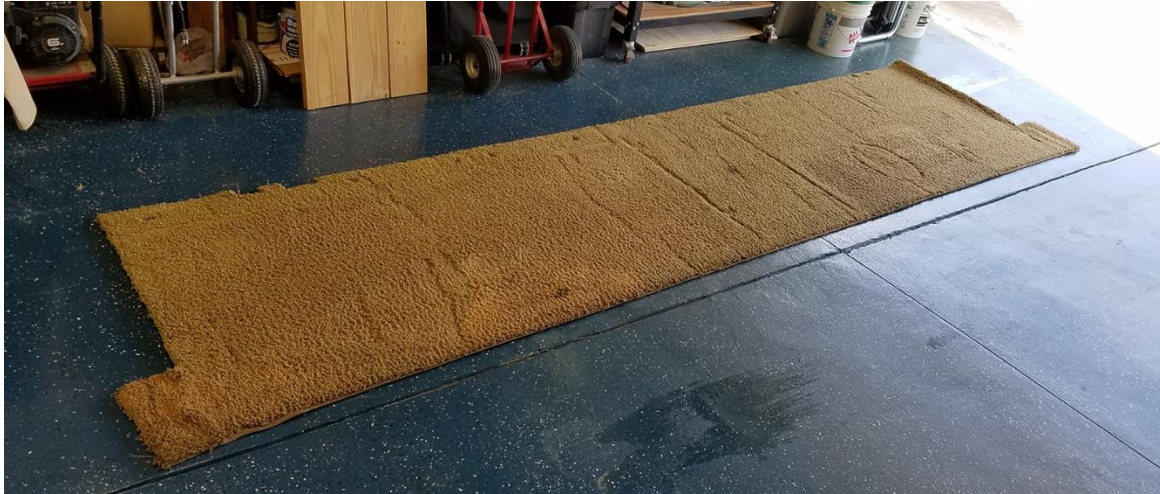
I used the old carpet to transfer the pattern to the new carpet but double checked the pattern against the coach measurements before cutting. NOTE: Always ensure that the carpet nap runs the same direction for every piece installed or it will look like you used two different carpets!

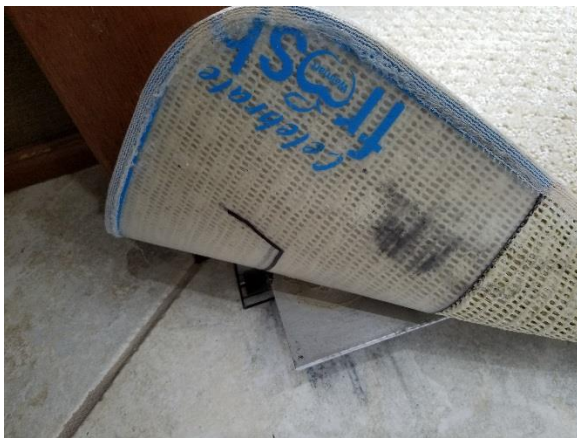
Flexible plastic corner stiffener

Once the two pieces of carpet were cut and test fitted in the coach it needed to be seamed together. I could have bought \$100 worth of seaming tools for this one job but it made more sense to pay \$16 and have the carpet supplier to professionally seam it for me. Once it was seamed, test fitted and final trimming, I took it back to the carpet supplier to get the outside edge bound and it was ready for installation. We rounded the outside corners and bound a flexible plastic stiffener into each of the corners to avoid the flop-eared look the original carpet had.

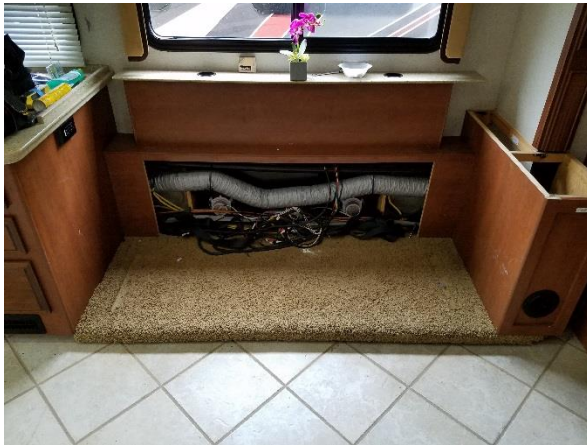
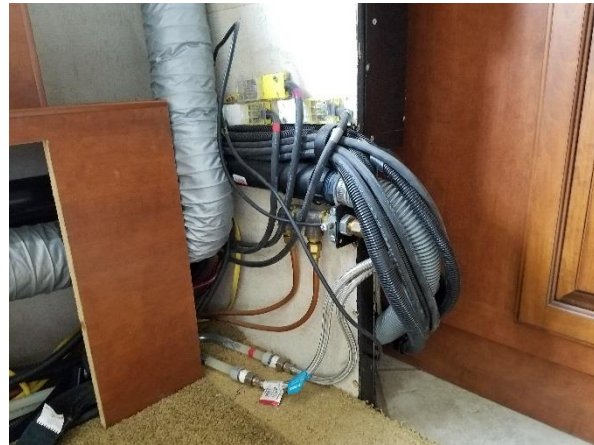
There was one screw at each end of the sofa back to remove and the entire back slips up and off the sofa. Opening the sofa allowed me to remove six bolts on each side of the frame and the rest of the sofa could be removed. We can now see the slide carpet, mostly. We will also need to unscrew the side cabinet as the carpet goes under it. This gives us a good look at the connections for power, water, sink drain, and gas connections to the slide.

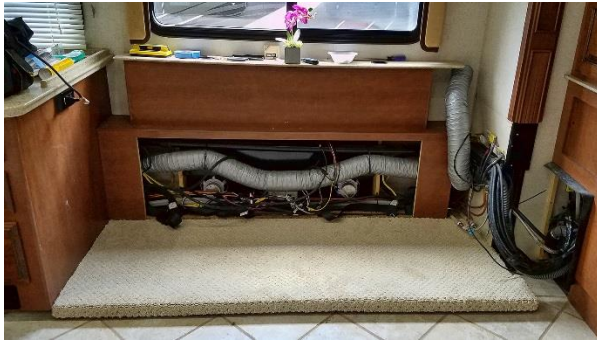
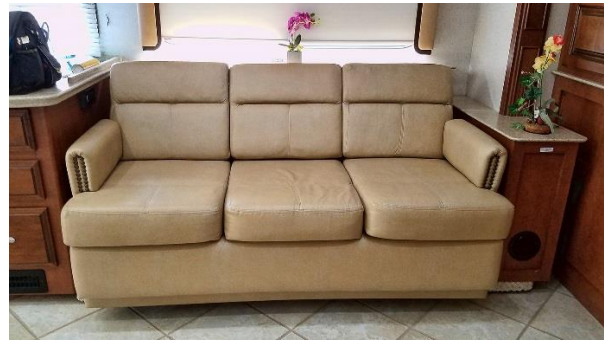
There was no benefit to removing the back cabinet as none of the area can be seen so I only removed the old carpet up to that back cabinet. Meanwhile, I can inspect all of the slide connections with the slide both in and out and check for any problems that might be lurking there. There is no carpet binding needed so it is a straightforward cut and replace of the carpet. Replacing the cabinet and Sofa was relatively easy, however, I found that several of the sofa bolts were stripped in the slide floor so I replaced all 12 with the next larger diameter bolt so that they all grip firmly. It is disappointing how little

of the new carpeting is visible but it gave me an untouched piece of the original carpeting for use later in the process.

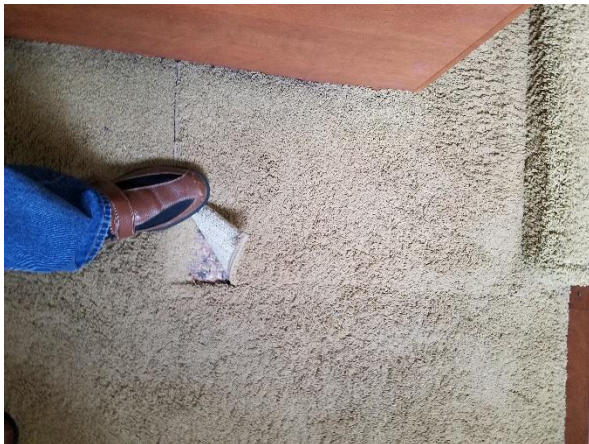
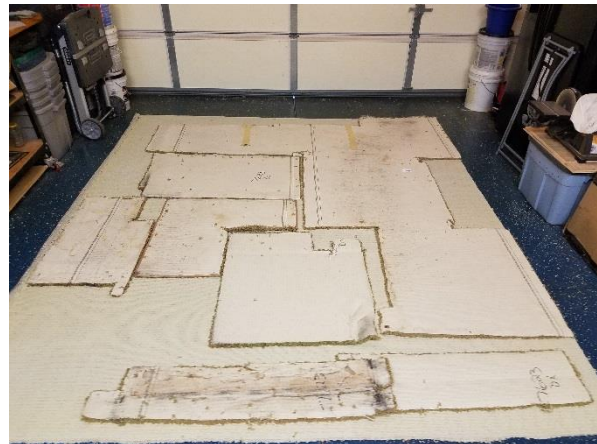
The bedroom differed in that it had a pad under the carpet and also strips of wood around the perimeter similar to tack strips but without any tacks in them. The pad was in good shape so I decided to reuse it given how little wear the bedroom carpet gets.

The carpet covering the engine access panel was edge-bound and uncomfortable under foot. It wasn't possible to get to the engine access panel screws without pulling up the carpet and having staples exposed as the screw heads were hidden. The carpet on the step in front of the closet was glued to a metal plate with silicone. The bedroom and closet carpeting was removed and used as a pattern to arrange optimum use of the new carpeting while maintaining the direction of the nap.

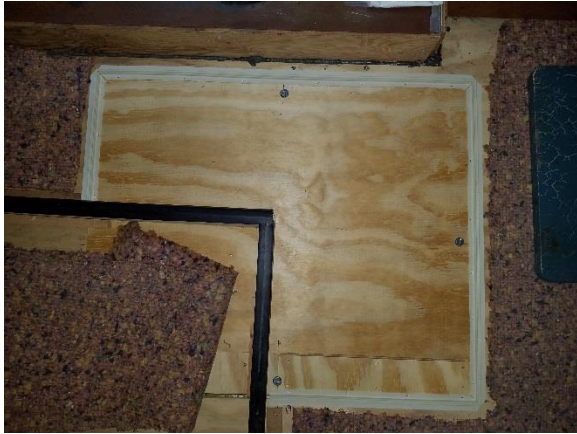
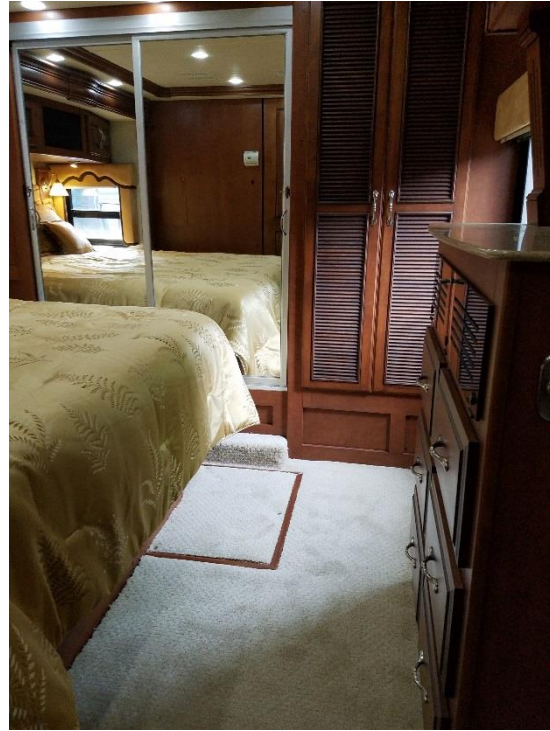
I stapled and glued a transition strip channel to the edge of the engine access panel and after the new carpet was installed put the transition cap over the junction of the two carpets. The panel screws are accessible from the top of the carpet but recessed so that they are below the height of the rest of the carpet. The idea is that if access to the top of the engine is required, the transition cap are popped off, the panel screws are removed, and the panel can be lifted out with the carpet still attached. Hopefully I'll never need to find out if that works as planned!

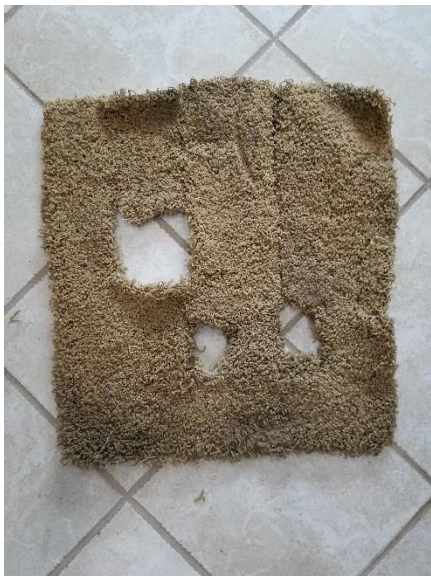
There were small pieces of carpet replaced in the bathroom, left of the refrigerator, beside the entry and under the captain's chairs. The carpet under the driver's pedals was a different matter. That area gets way too much soil to be a candidate for light colored carpeting so I used some of the "new" condition carpeting that was removed from under the sofa to replace the carpet under the driver's pedals. Someday I may replace this carpet with a darker color but for now, this is acceptable.
