Full Wall Slide Won't Move Troubleshooting and Repair 2014 Discovery 40F

INTRODUCTION/SUMMARY

This file documents troubleshooting an inoperative full wall slide on a 2014 40F Discovery. The malfunction occurred during the January 2019 SE DOAI Rally at Lazy Days RV Resort. Several people (Mike Weiher, Kerry Pinkerton, Jim Pinkerton, Rick Blaher, Harry Terrill, Marshall Godwin (remotely)) participated in the process over a period of 4 days during the rally. Mike owns the coach and Rick acted as the scribe. The others combined their knowledge and troubleshooting skills to identify and correct the malfunction's cause. We also had consultation with REV Technical Support during the process. All the full wall system major components were checked and eliminated to arrive at the root cause. A relay was found on the floor under the center dash that had gotten wet and was damaged. The relay was replaced and the problem resolved. The following slides and narrative document the troubleshooting and repair process.

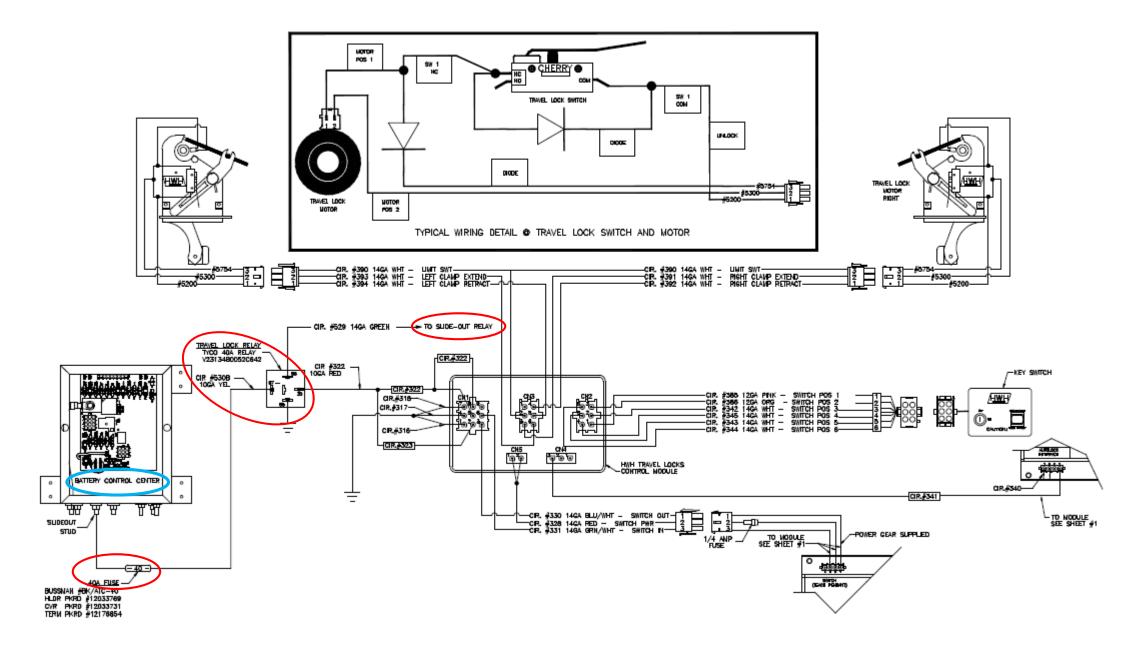
Reference Diagram 2

This plug was disconnected and jumpered to cause the slide to move in and out. See Reference Diagrams 2 & 3
